Debris/Ice/TPS Assessment And Integrated Photographic Analysis For Shuttle Mission STS-49

July 1992

Gregory N. Katnik
NASA/Kennedy Space Center

OV-105 Endeavour (1st flight), ET-43 (LWT 36), BI-050 SRBs

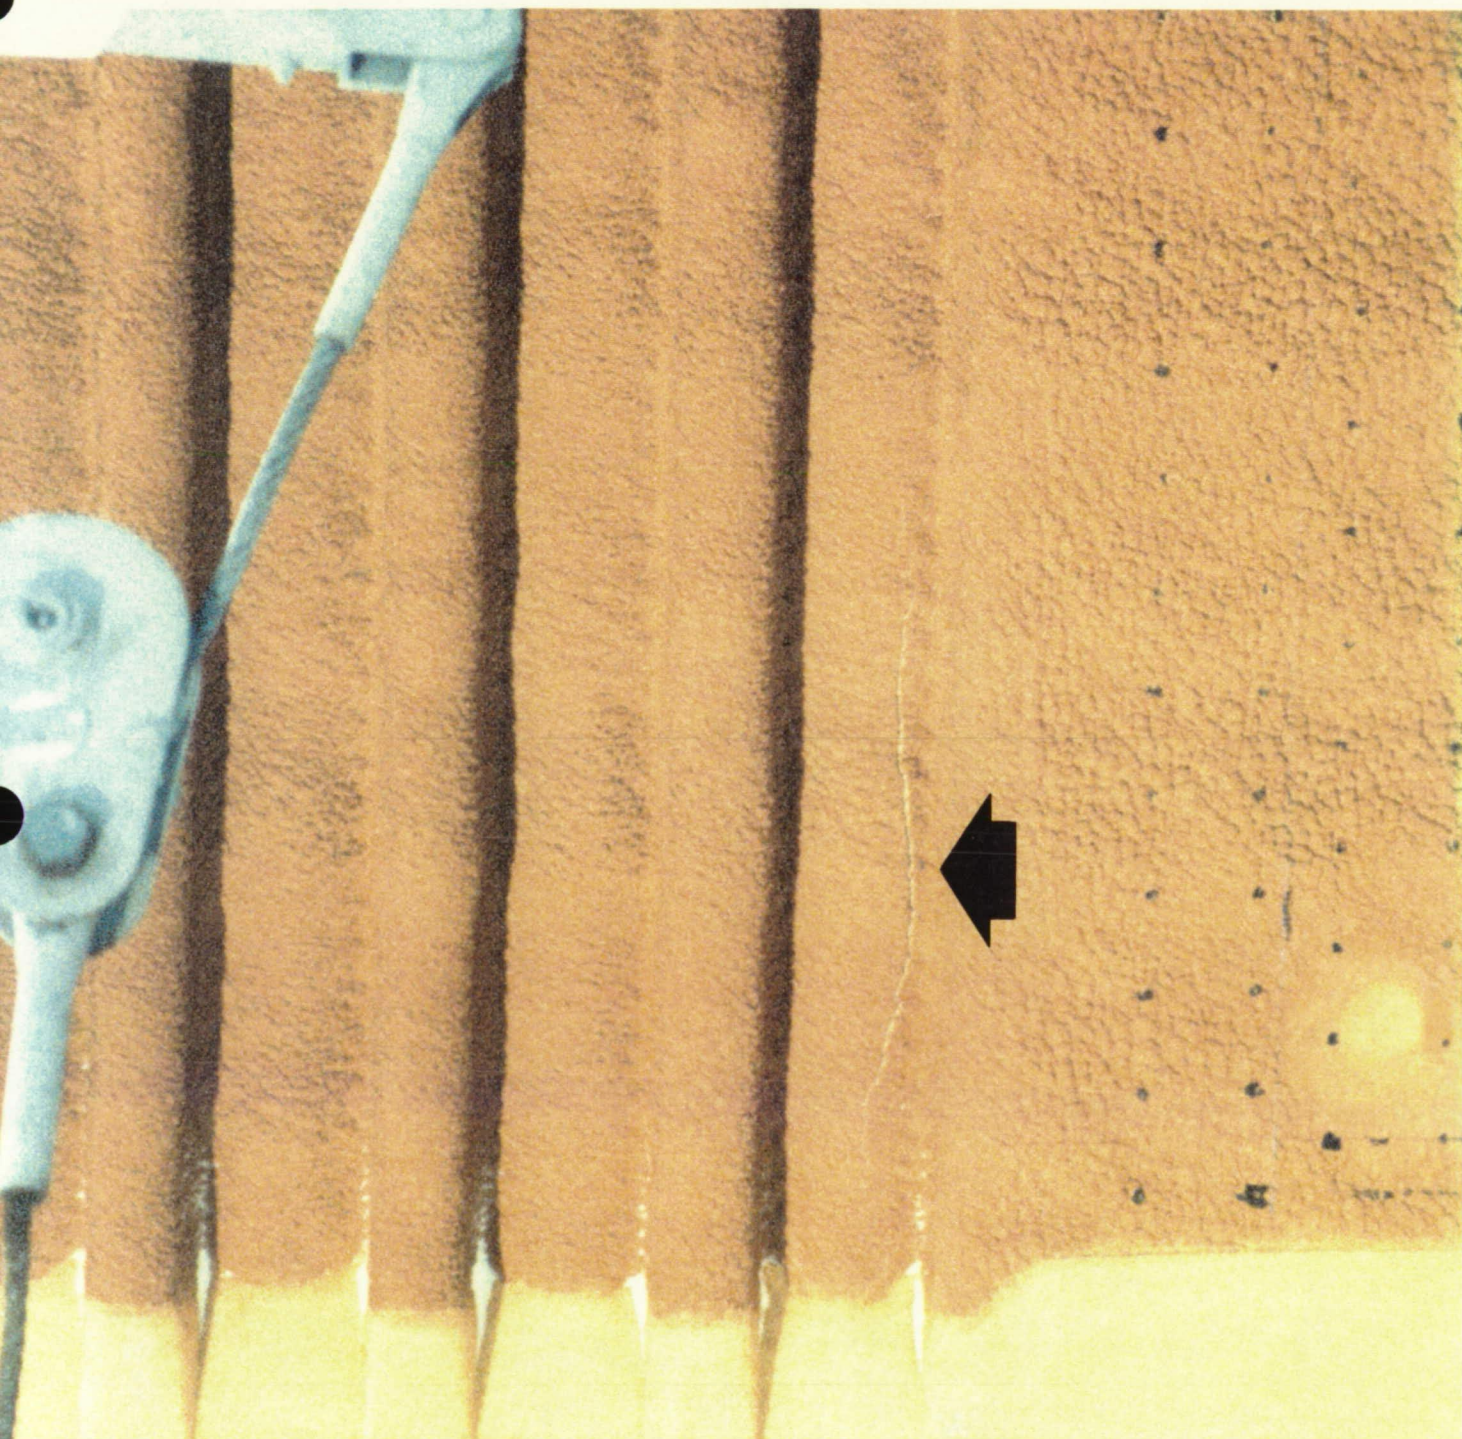
Thermal stresses caused a crack in the intertank TPS (-Y-Z quadrant) in the first stringer valley adjacent to the -Y thrust panel beginning at the LH2 tank-to-intertank flange and propagating forward. The crack was 18-20 inches long, 1/4-inch wide with no offset, and was not filled with ice or frost.

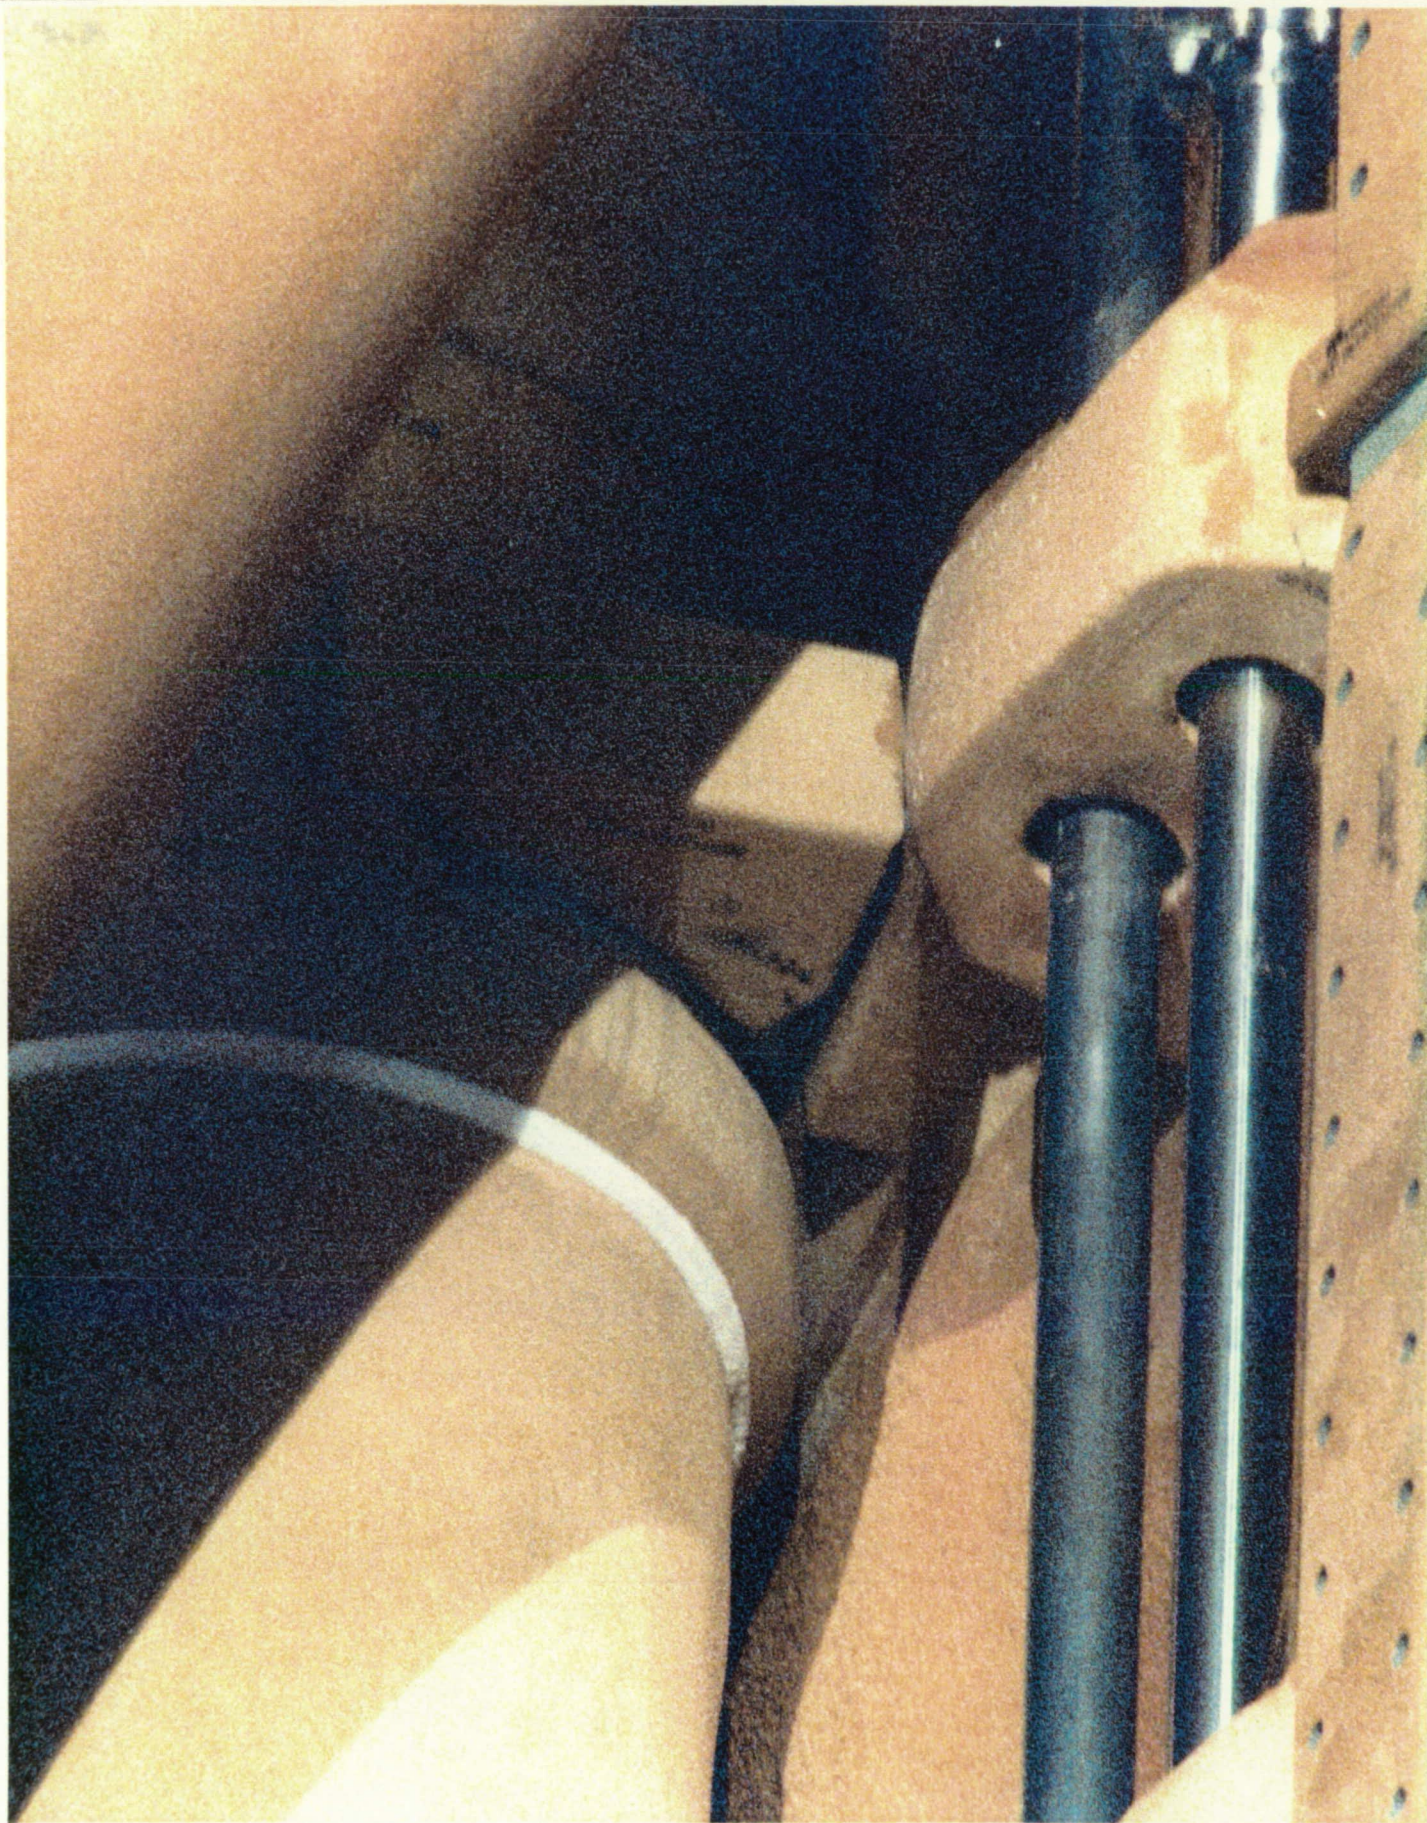
Typical amounts of ice had formed in the L02 feedline bellows

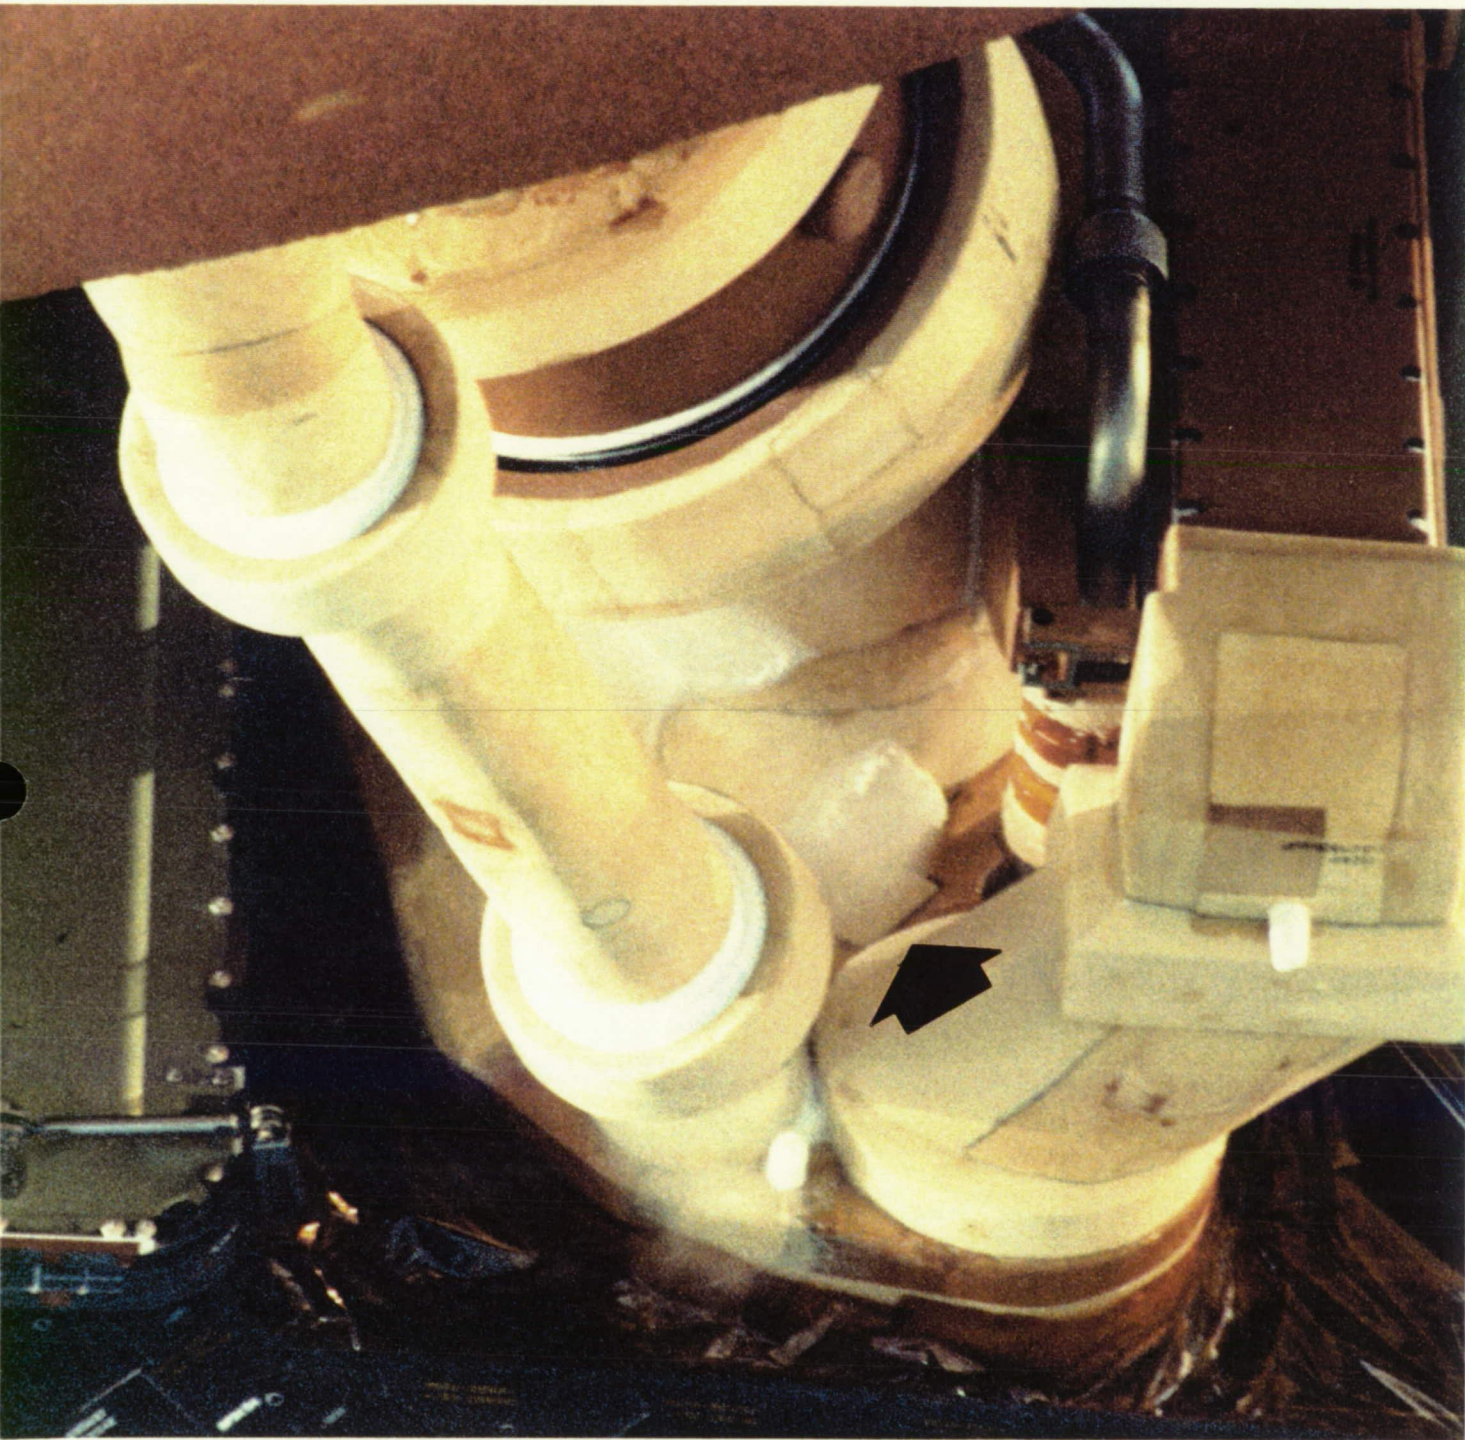
Ice/frost had formed on the thin TPS around the aft pyrotechnic canister closeout and bondline. A 4-inch ice/frost formation with venting (blowing) purge gas was present on the 17-inch flapper valve actuator access port foam plug forward corner.

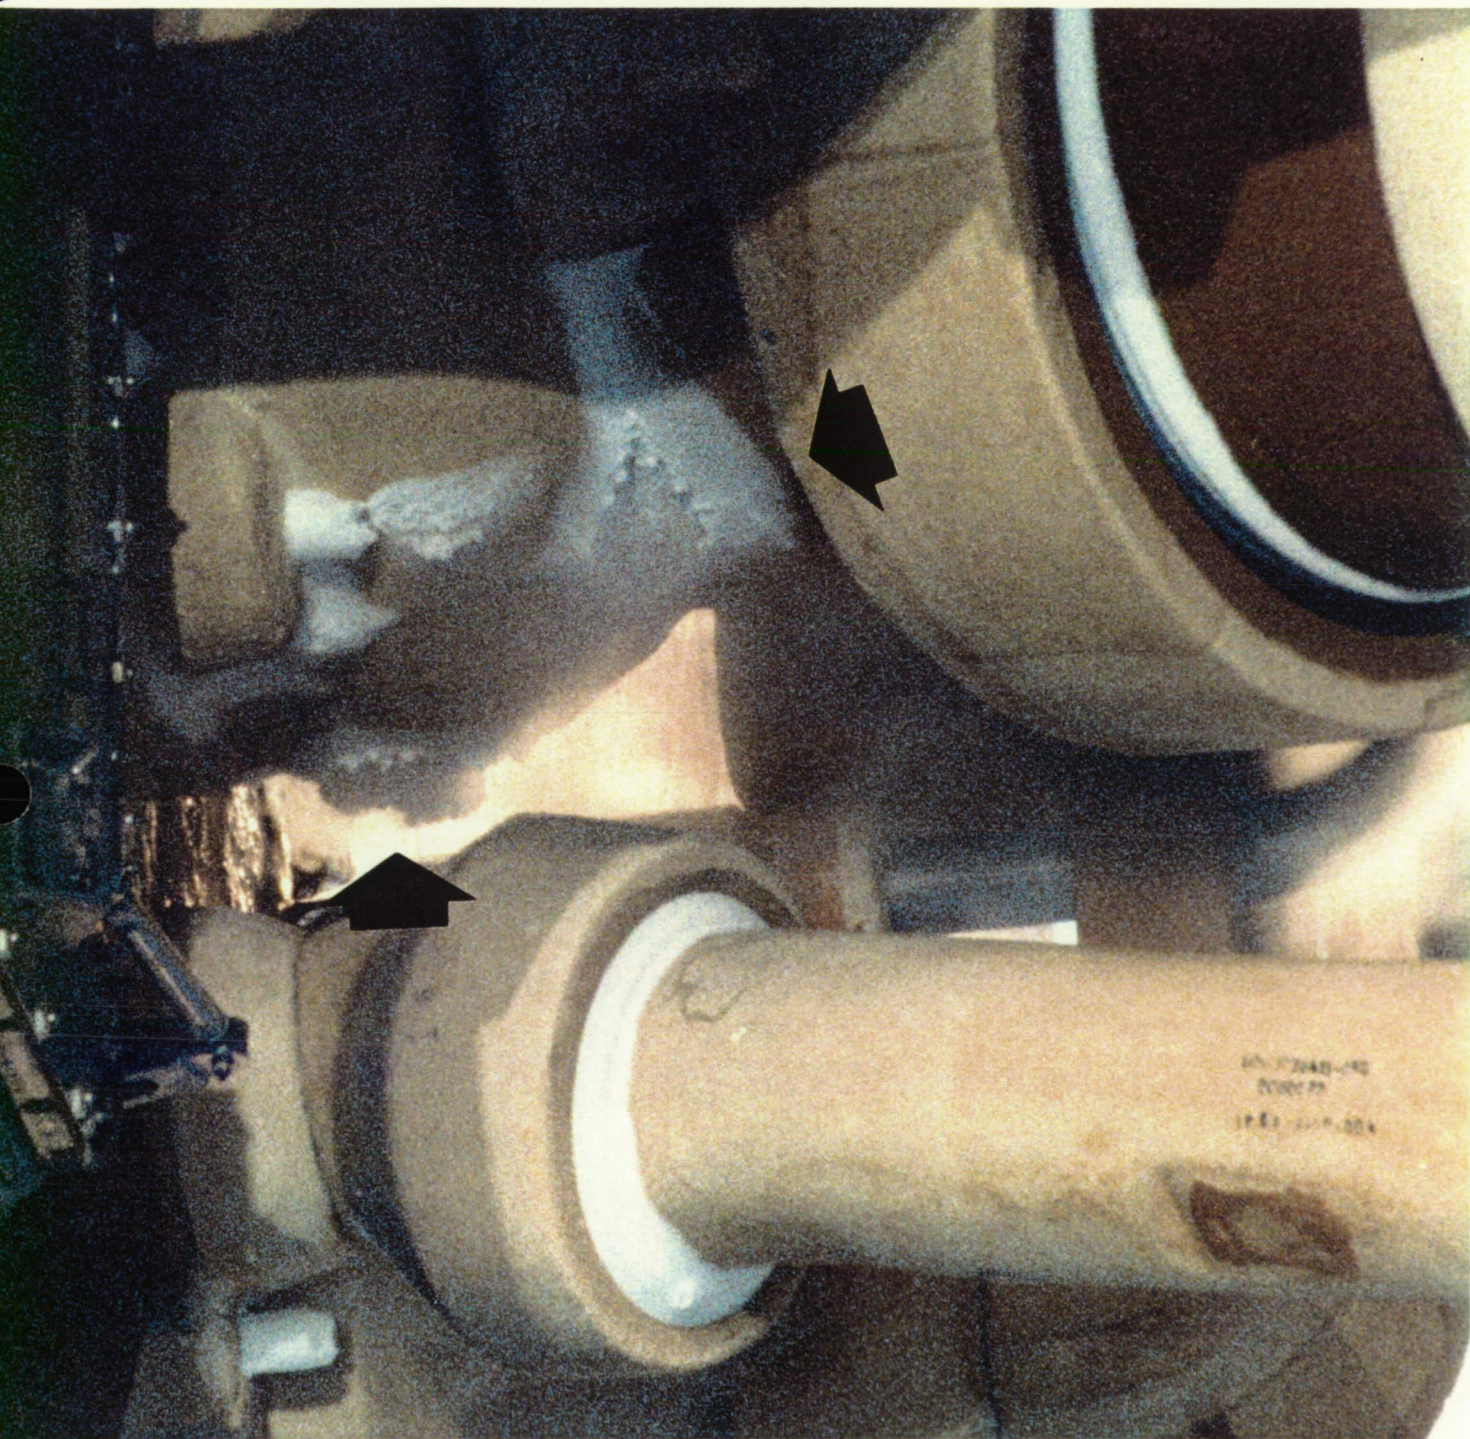
Ice and frost accumulations on the aft side of the LH2 feedline were the result of cold purge gas impingement from the venting (blowing) TPS plug closeout. Ice/frost in the recirculation line bellows, feedline bellows, and purge vents was typical.

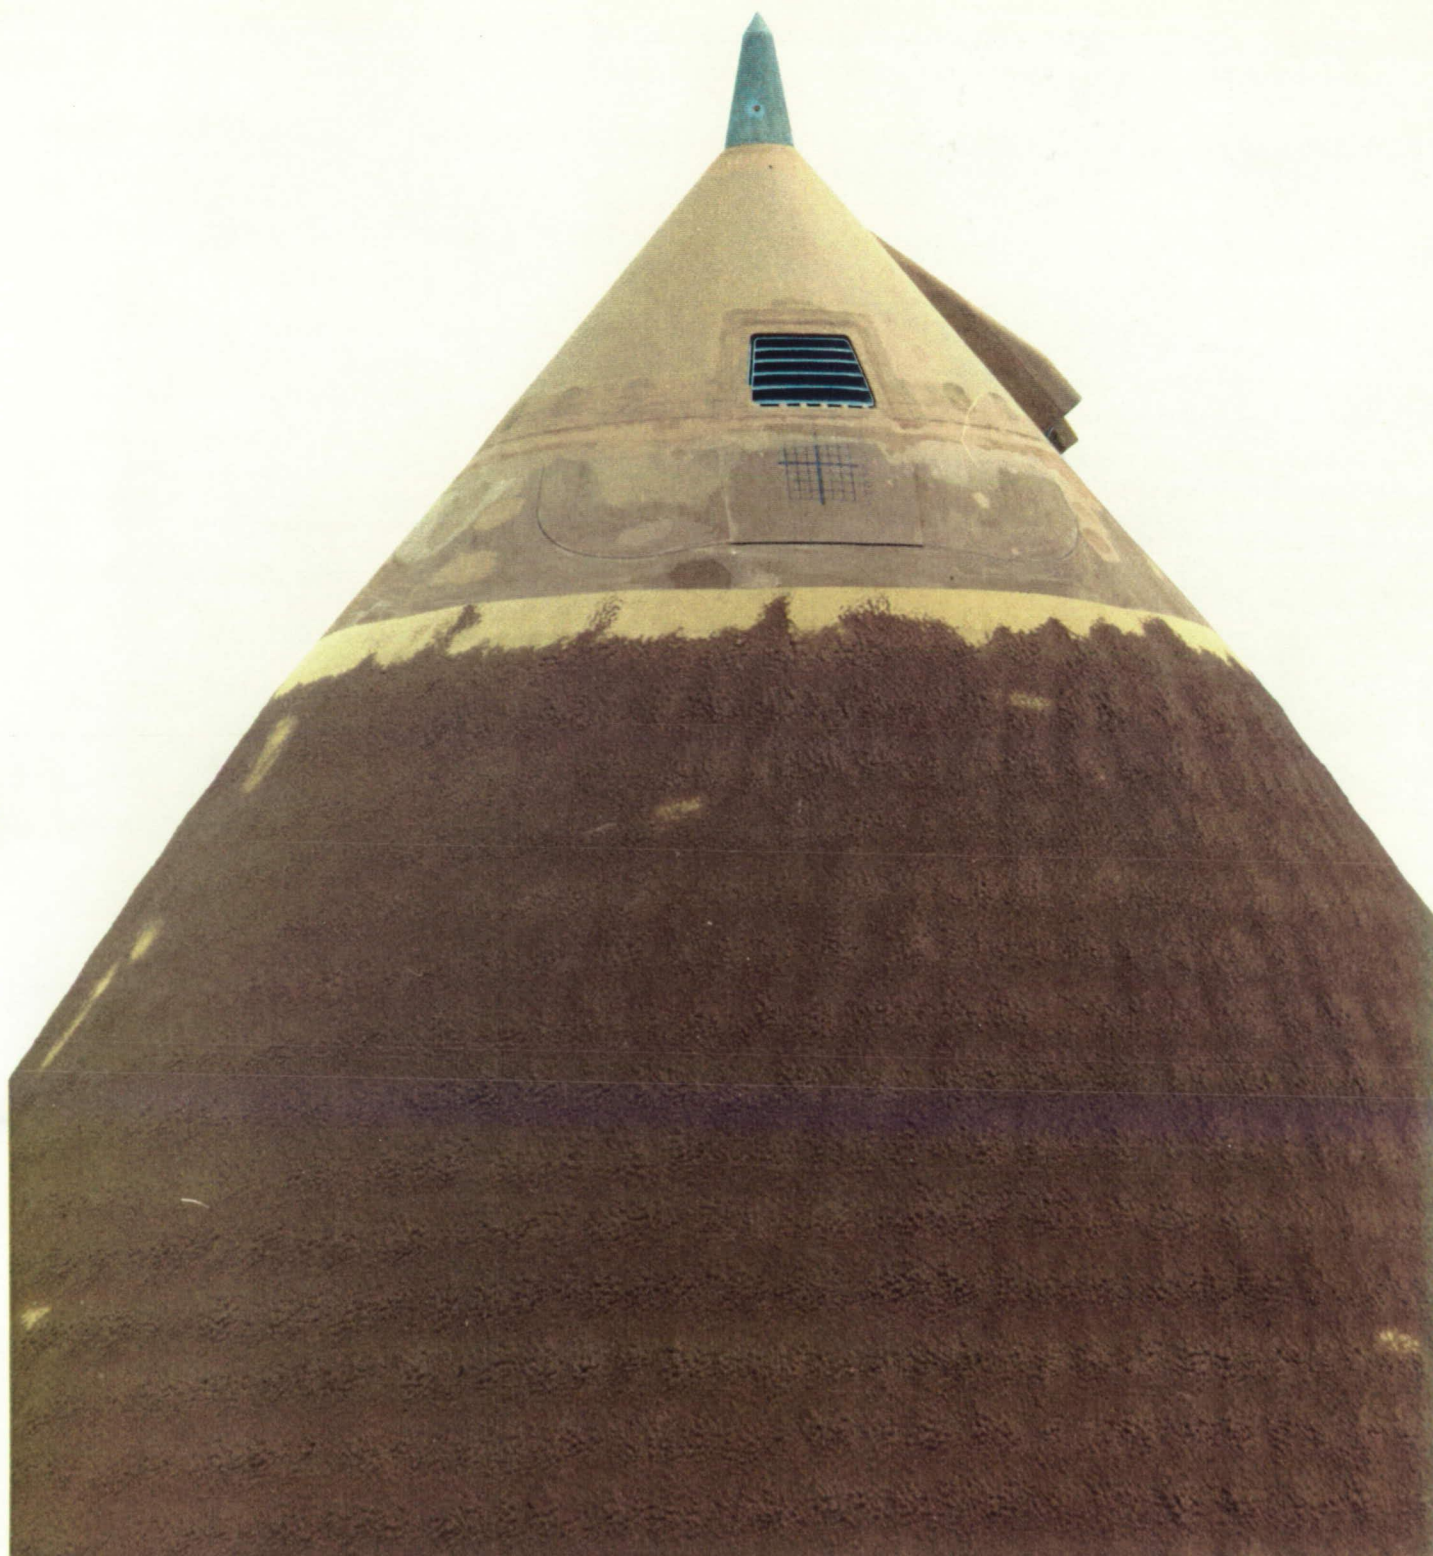
There were no significant anomalies on the nosecone, fairing, and louvers. Five small areas of topcoat were missing near the grid due to chafing from the GOX vent seals.

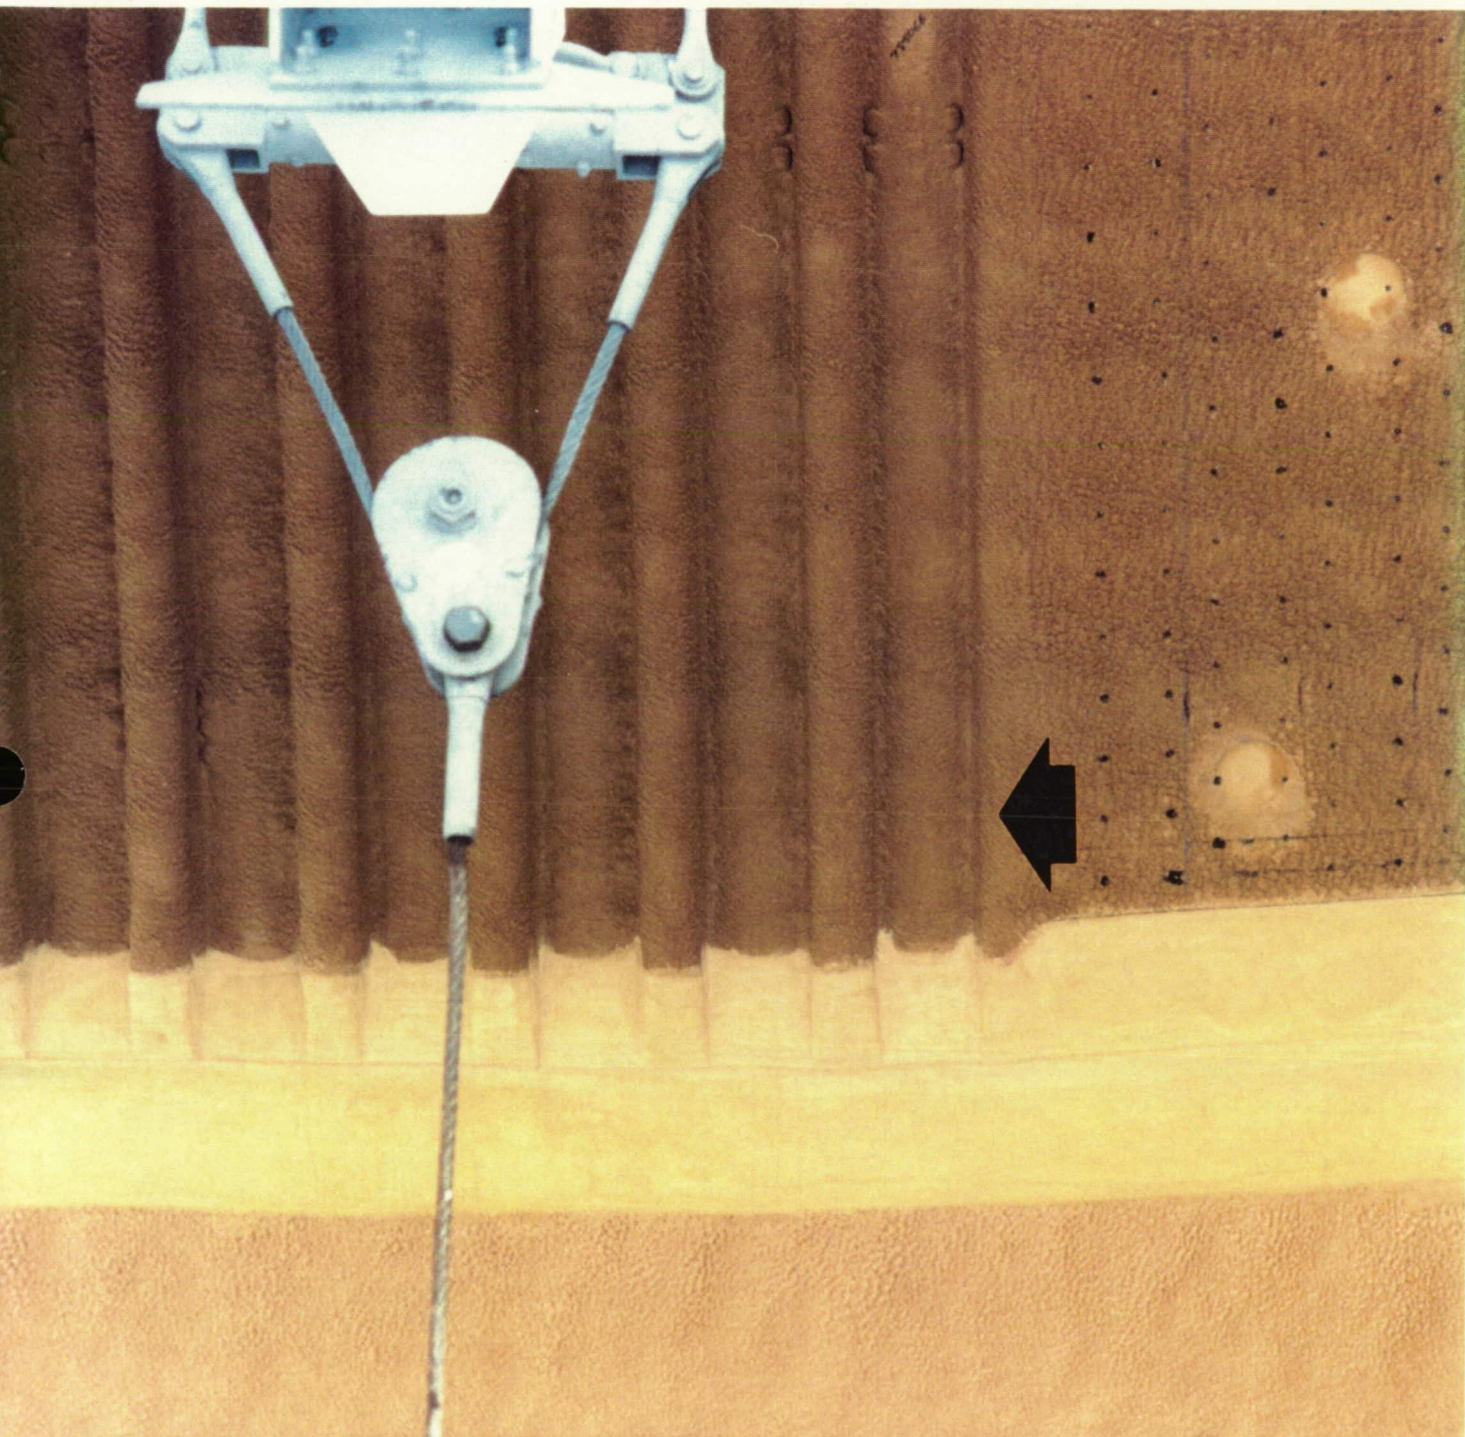
The thermal stress crack that had appeared in the intertank stringer valley adjacent to the thrust panel had closed during tank warm-up and was not visible during the Drain Inspection.

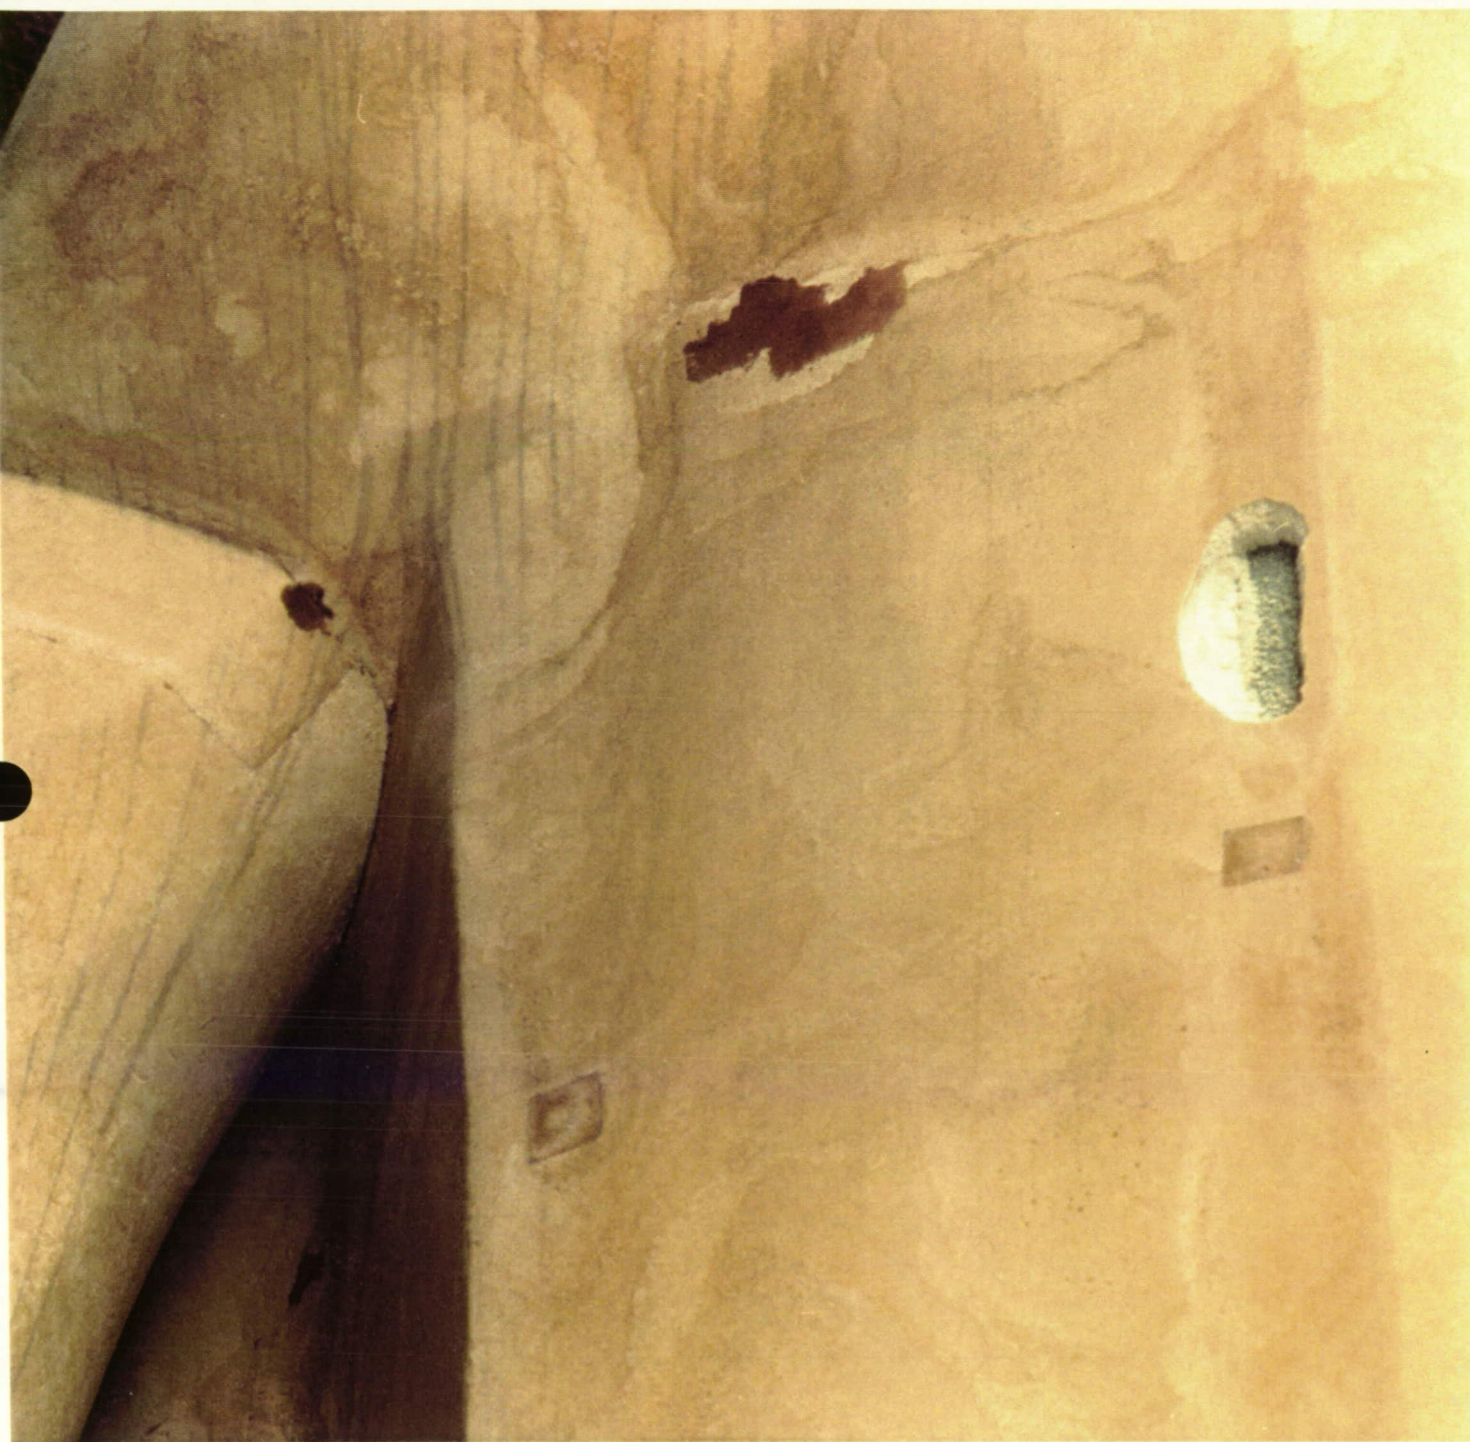
A 4"x3"x1" divot occurred on the +Y longeron closeout near the thrust strut interface. The divot exposed the substrate/primer and was most likely caused by a combination of foam defect and the expansion/contraction of tanking.

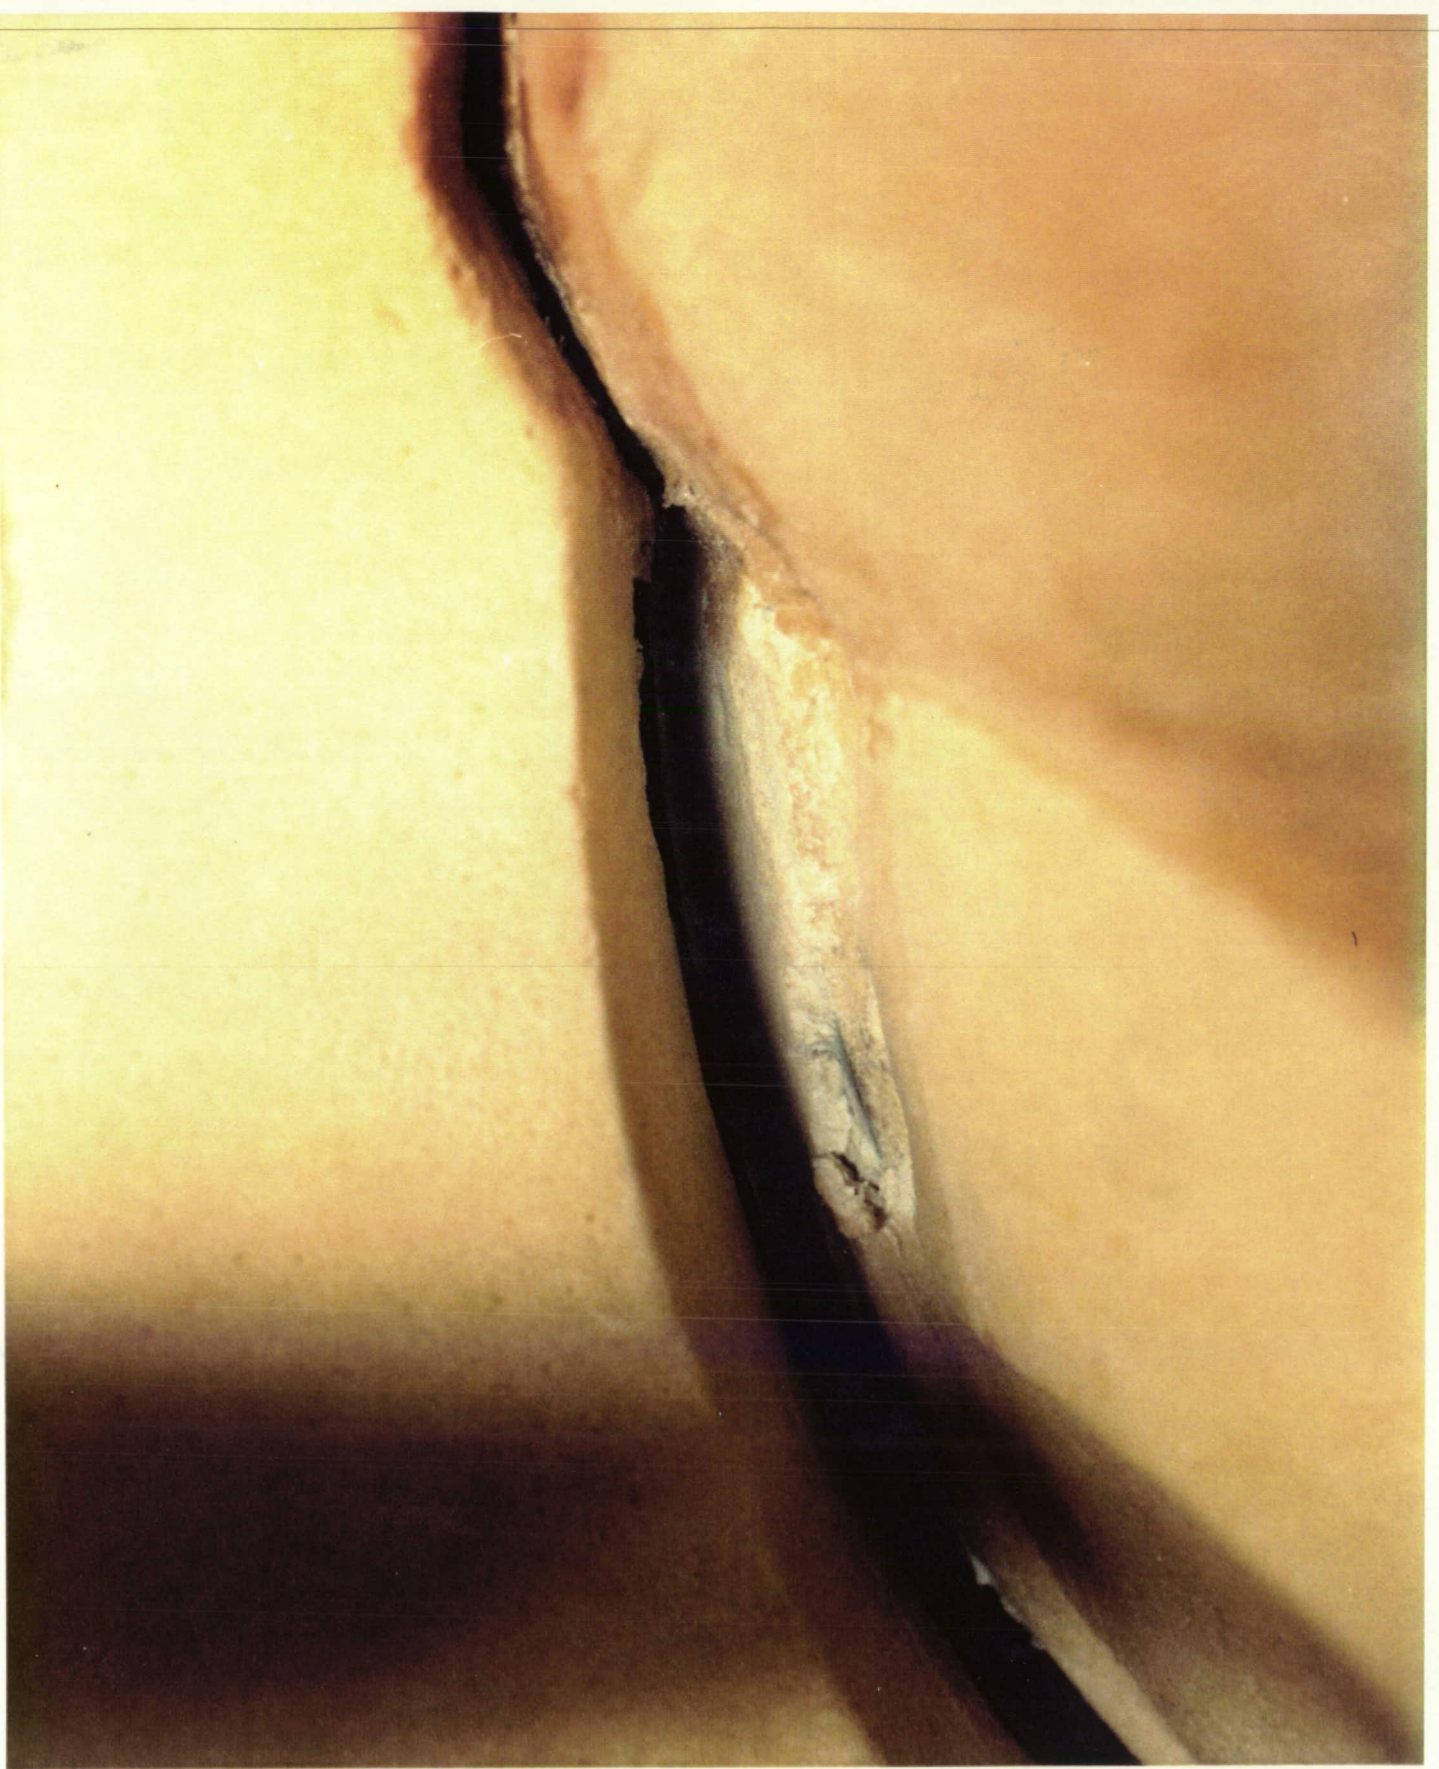
Inspection of the LO2 feedline support brackets revealed crushed/damaged BX-250 on the outboard side of the XT-1129 attach point at the feedline surface and some minor SLA damage on the boomerang bracket.

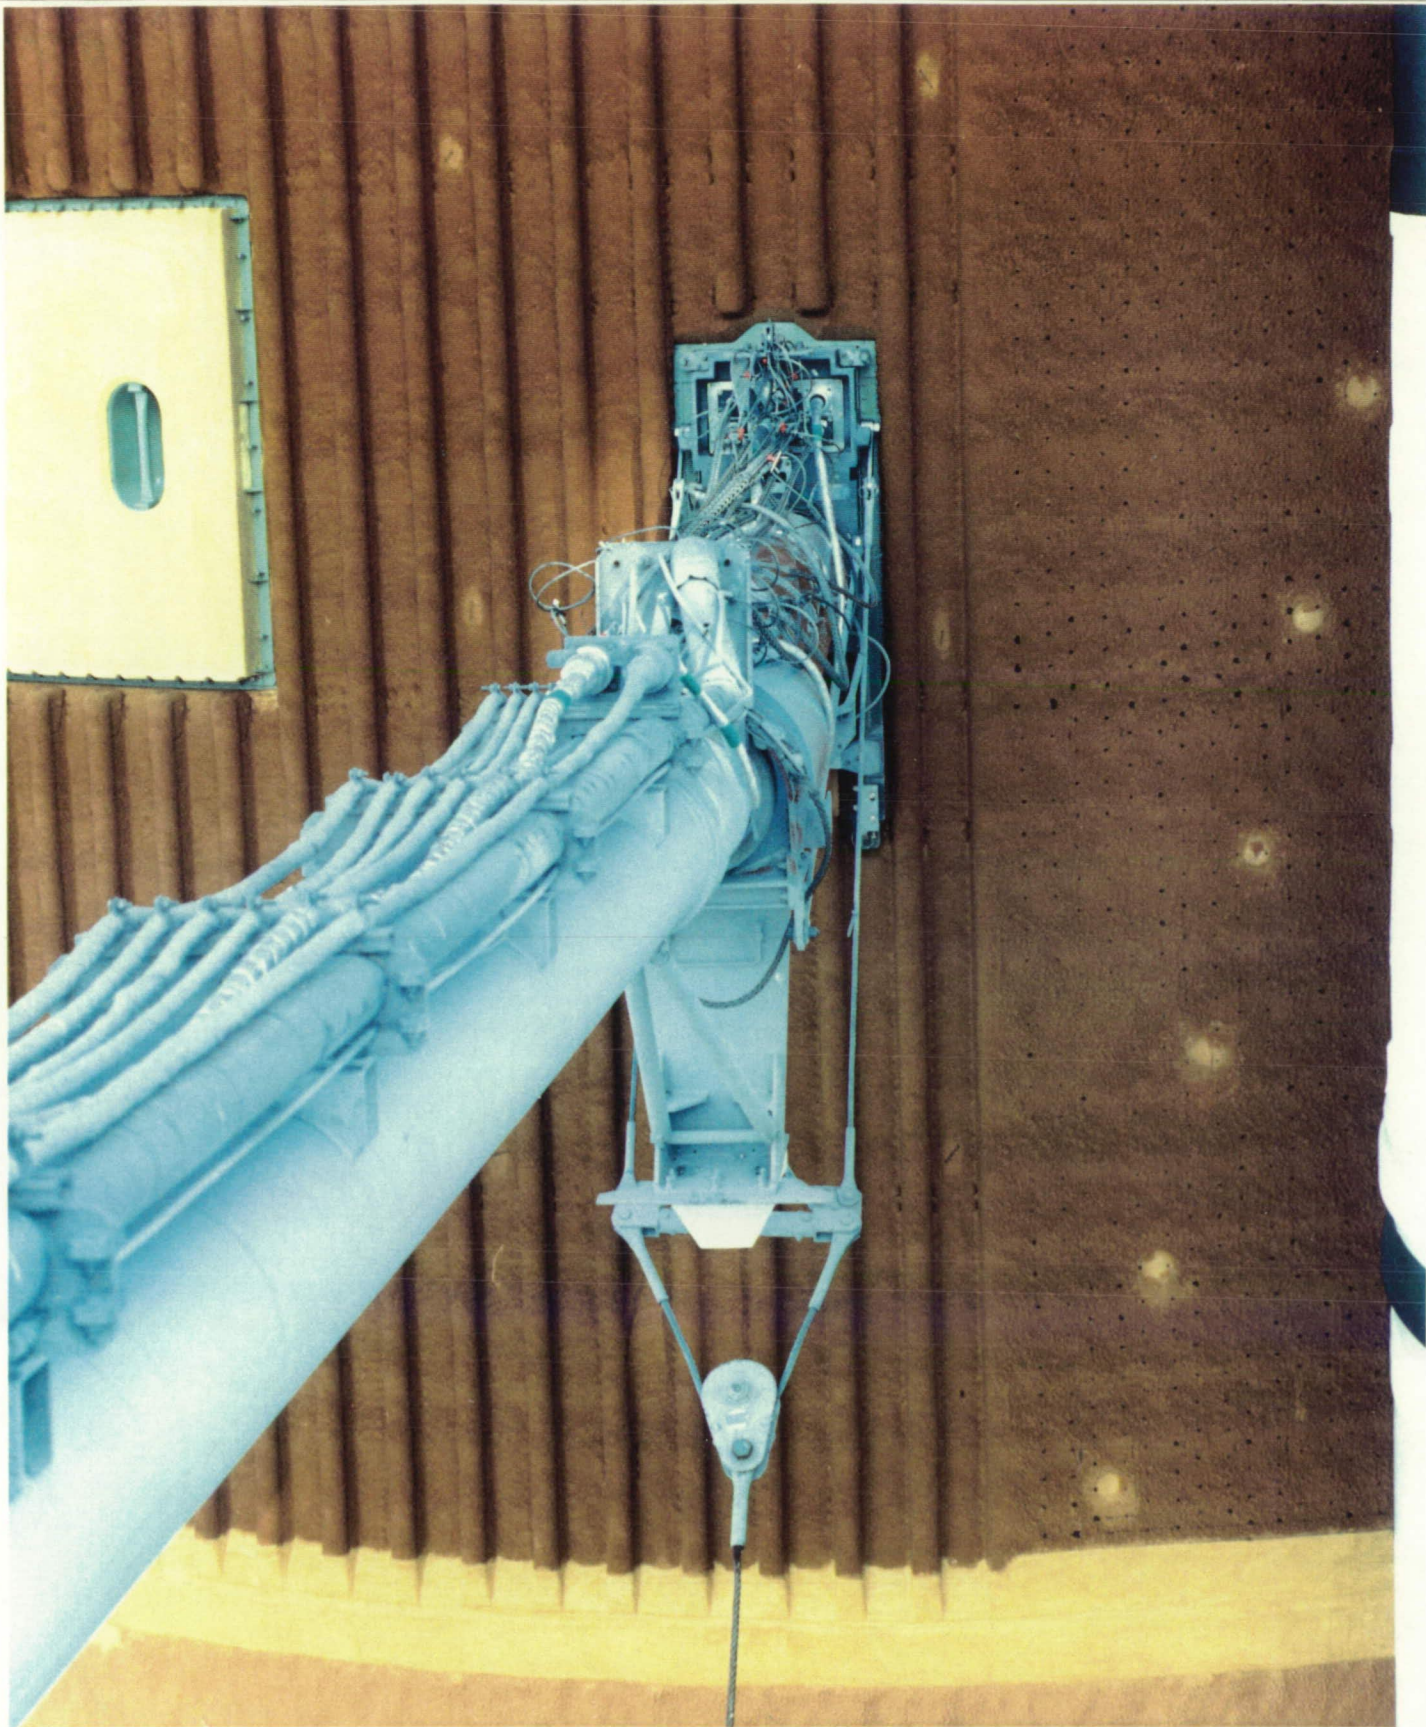
Overall view of the intertank TPS prior to cryogenic loading. A thermal stress crack, which had formed in the first stringer valley adjacent to the thrust panel during the FRF cryogenic loading, had closed up and is not visible when the tank is at ambient temperature.
